Investigation of Floor Vibrations in the "D" Wing of the Main Building of the Bureau of Engraving and Printing

Prepared for
Bureau of Engraving and Printing
4th and C Streets, S.W.
Washington, D.C. 20228

NBSIR 82-2599

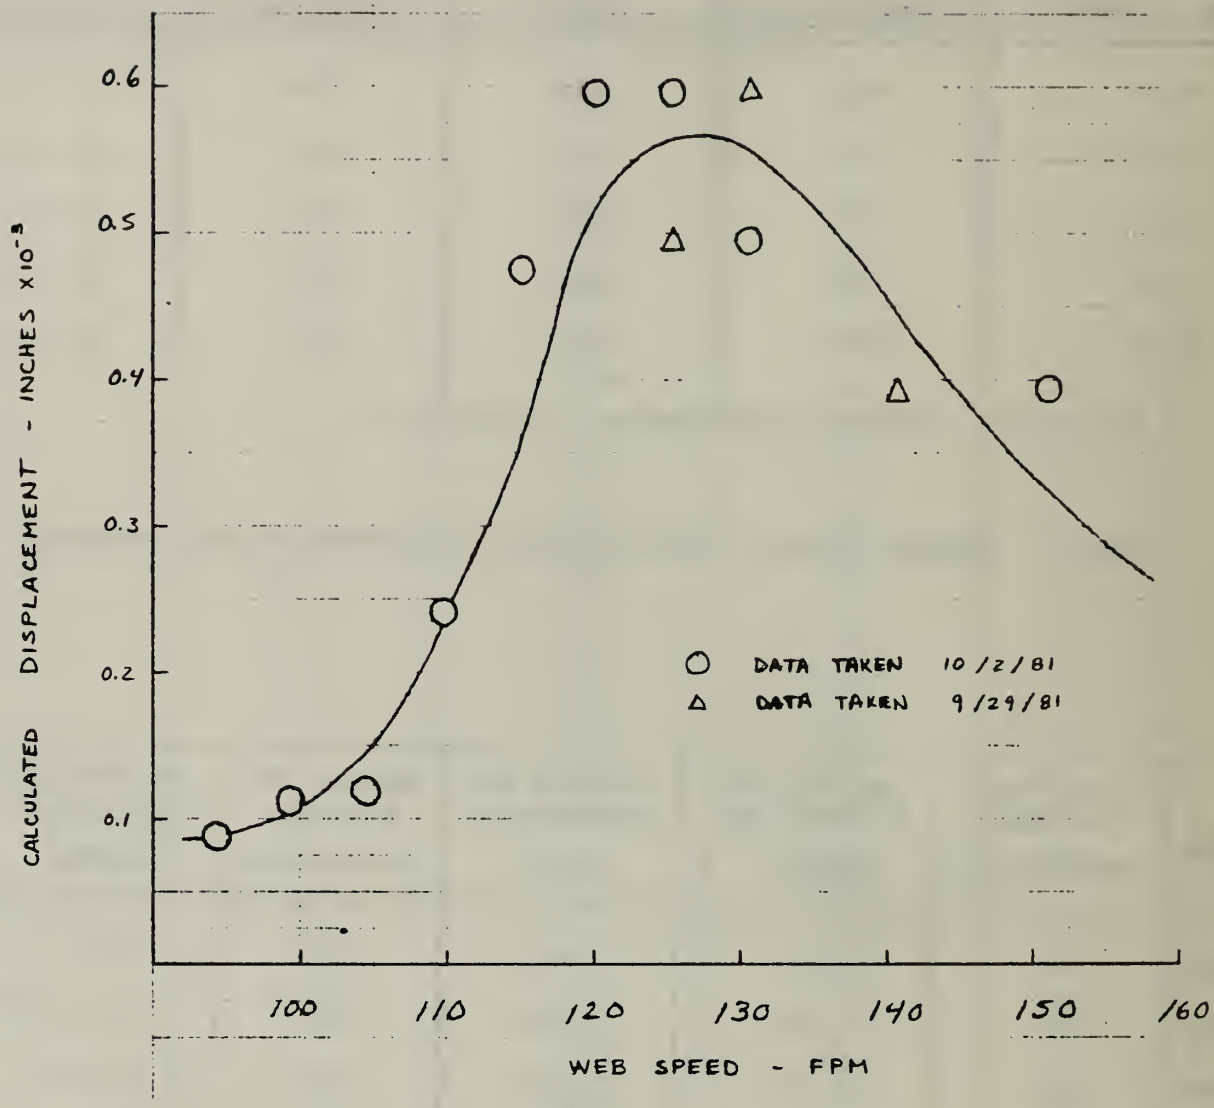
FIG. 1a: Estimated Vertical Floor Displacements of #1 Coiler/Perforator (North Machine) Provided by Bureau of Engraving and Printing Personnel.

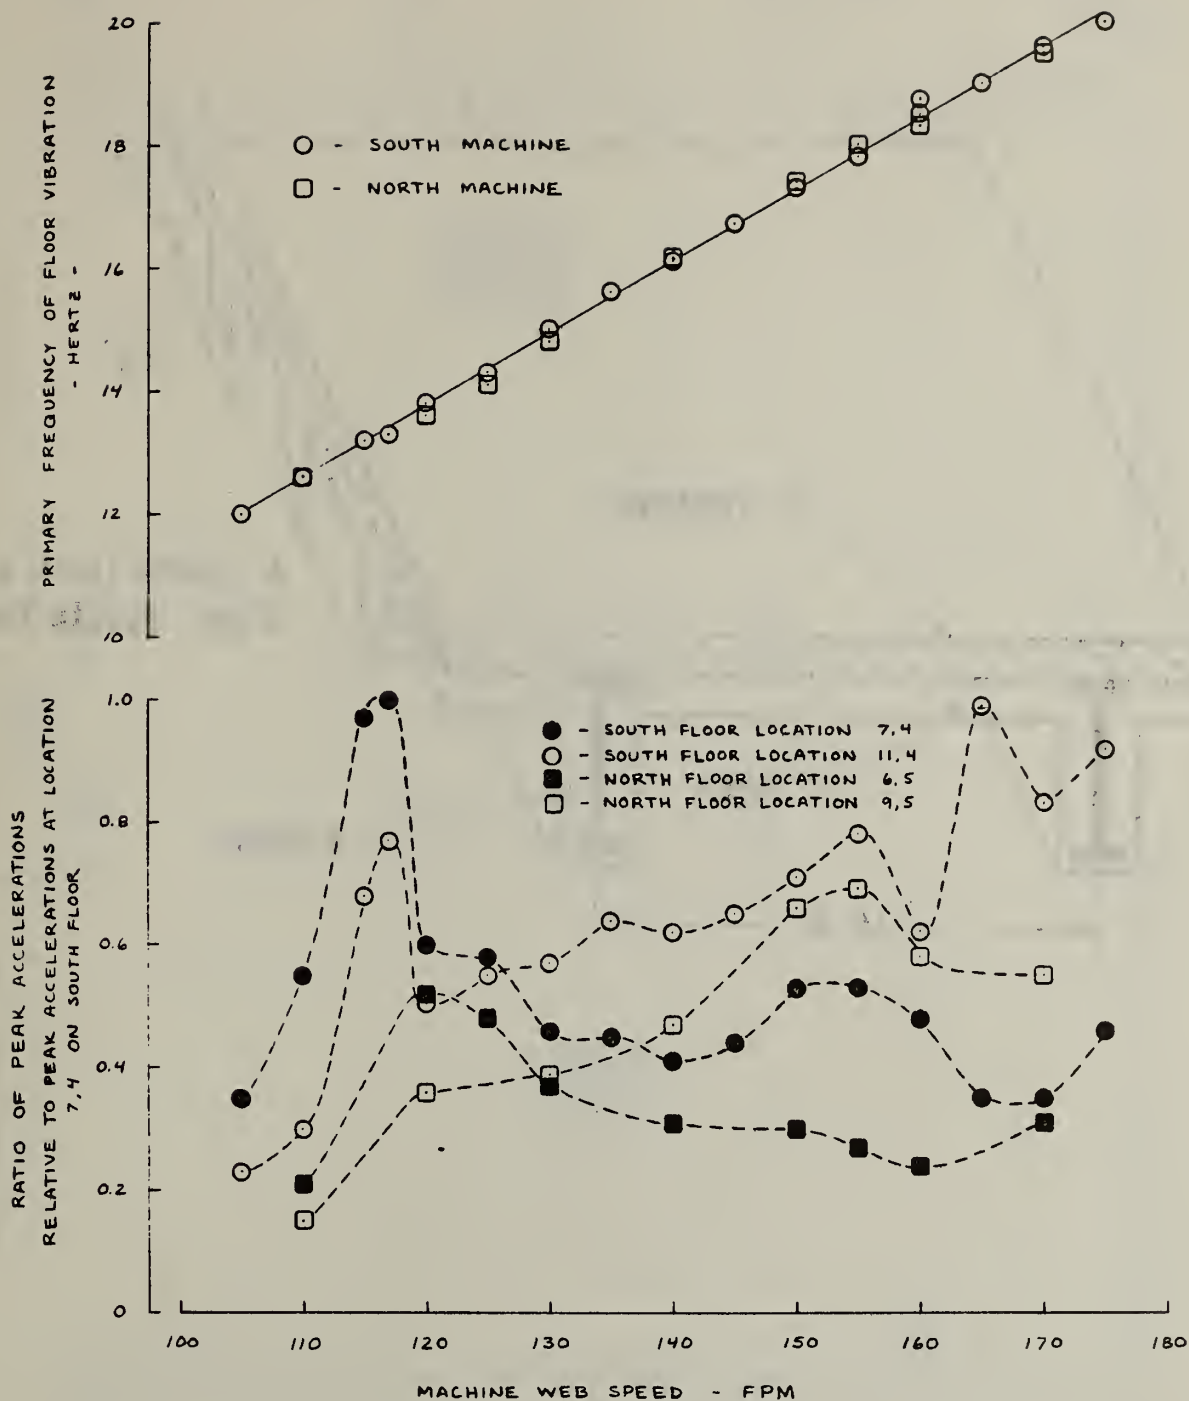
FIG. 1b: Relative Peak Accelerations of Primary Frequency of Floor Vibrations and Primary Frequency as a Function of Machine Web Speed.

The machines operate at variable speeds. The machine speed is defined in terms of the "web speed" (the speed at which the paper advances into the machine in feet per minute, 'fpm') and is set by the operator. Floor vibrations are sensitive to the operating speed as shown in Figs. 1a and 1b. Figure 1b presents the variation of vibration frequency with machine speed and the relative magnitude of floor vibration at two points for each floor studied as a function of machine speed.

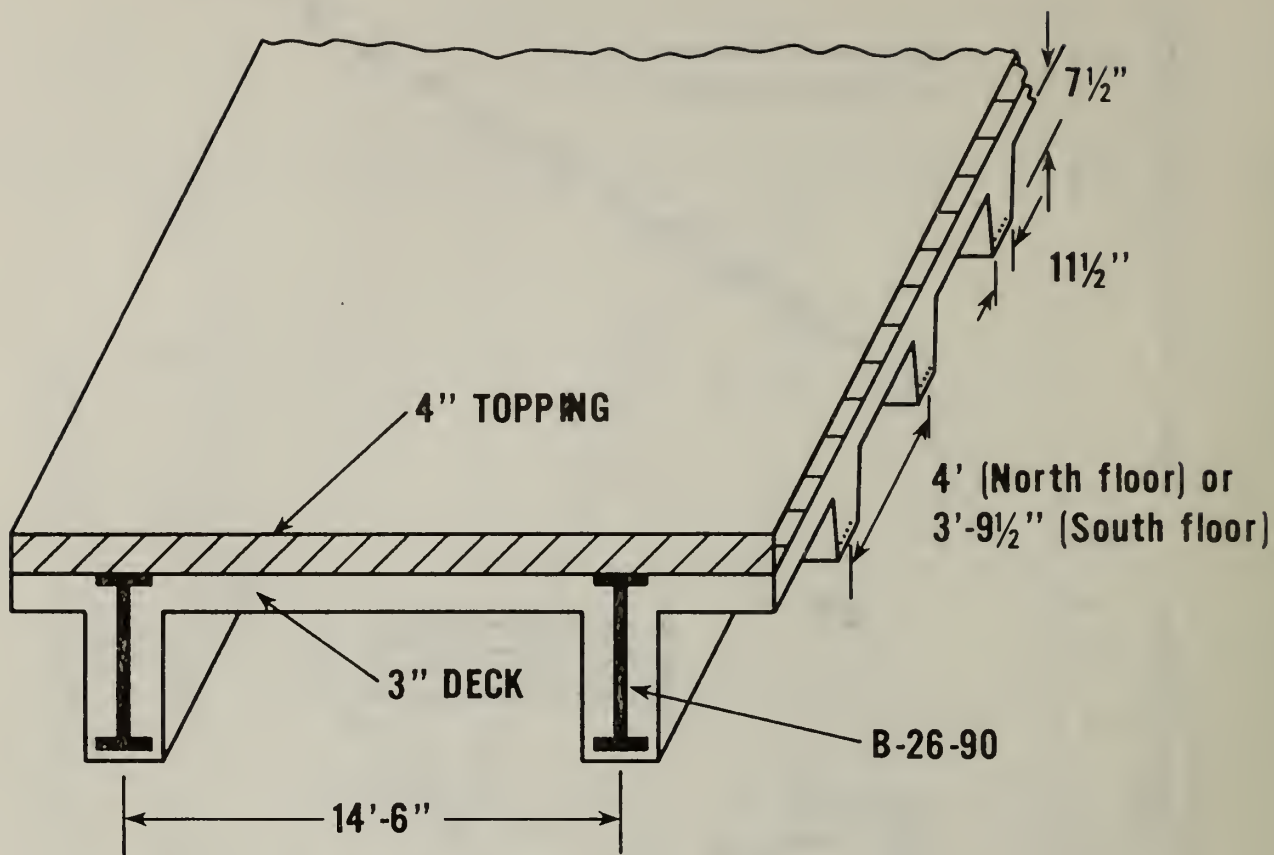
FIG. 2: Schematic Drawing of Typical Floor System Segment.

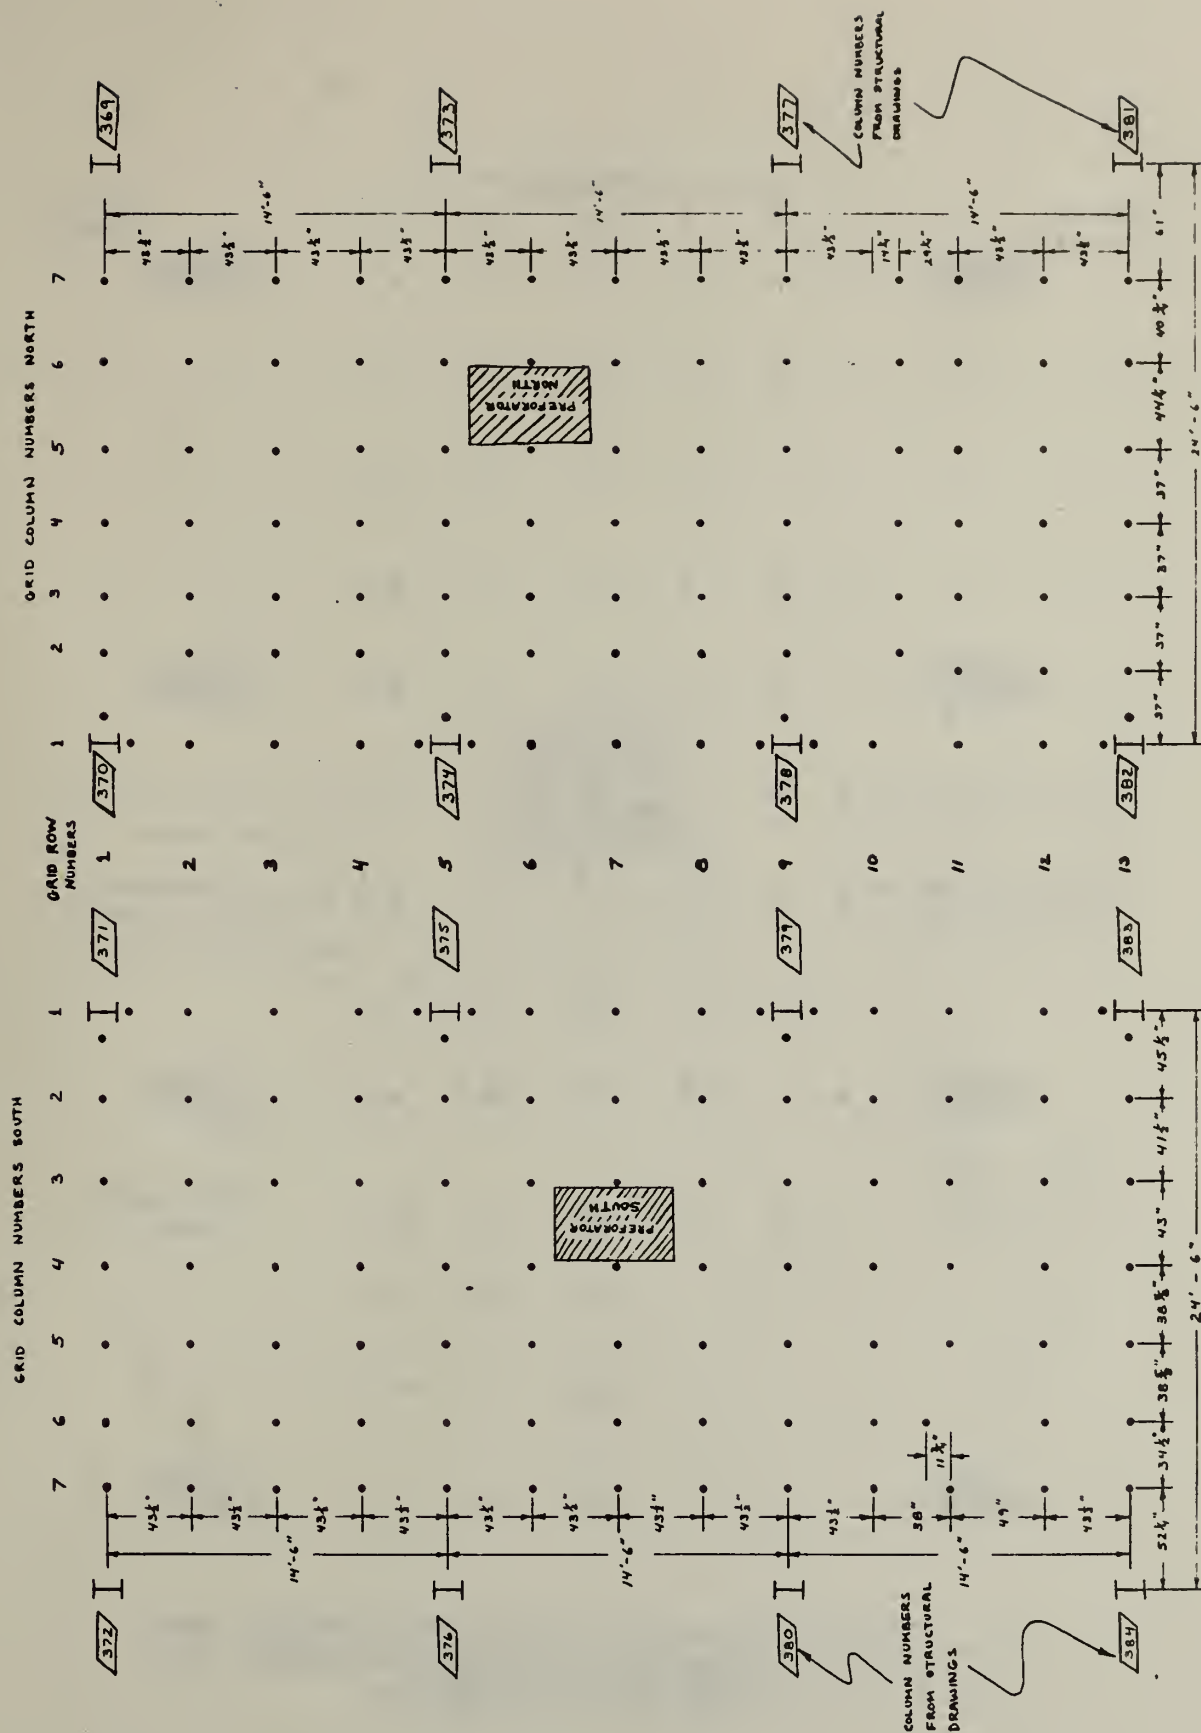
FIG. 3: Grid of Test Points (Dots indicate grid points).

Vibration measurements were made on the floor at selected locations on a grid laid out by Bureau of Engraving and Printing personnel. The grid points are shown in Fig. 3. Vibration tests were conducted on the floor systems under both machines because each machine is located differently relative to the columns and girders of the floor system.

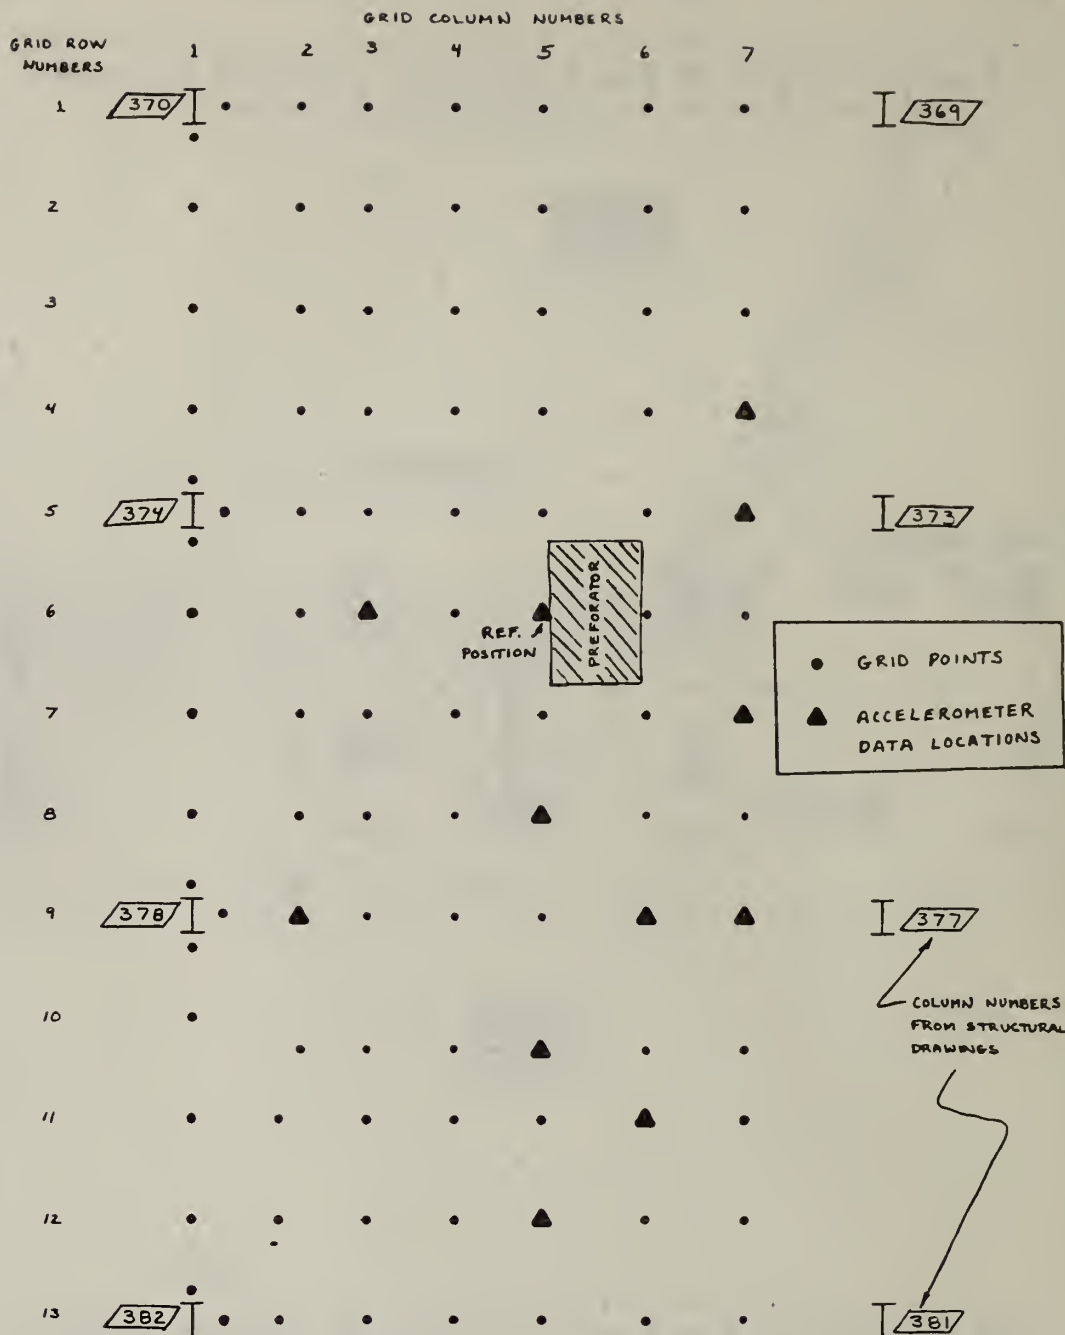
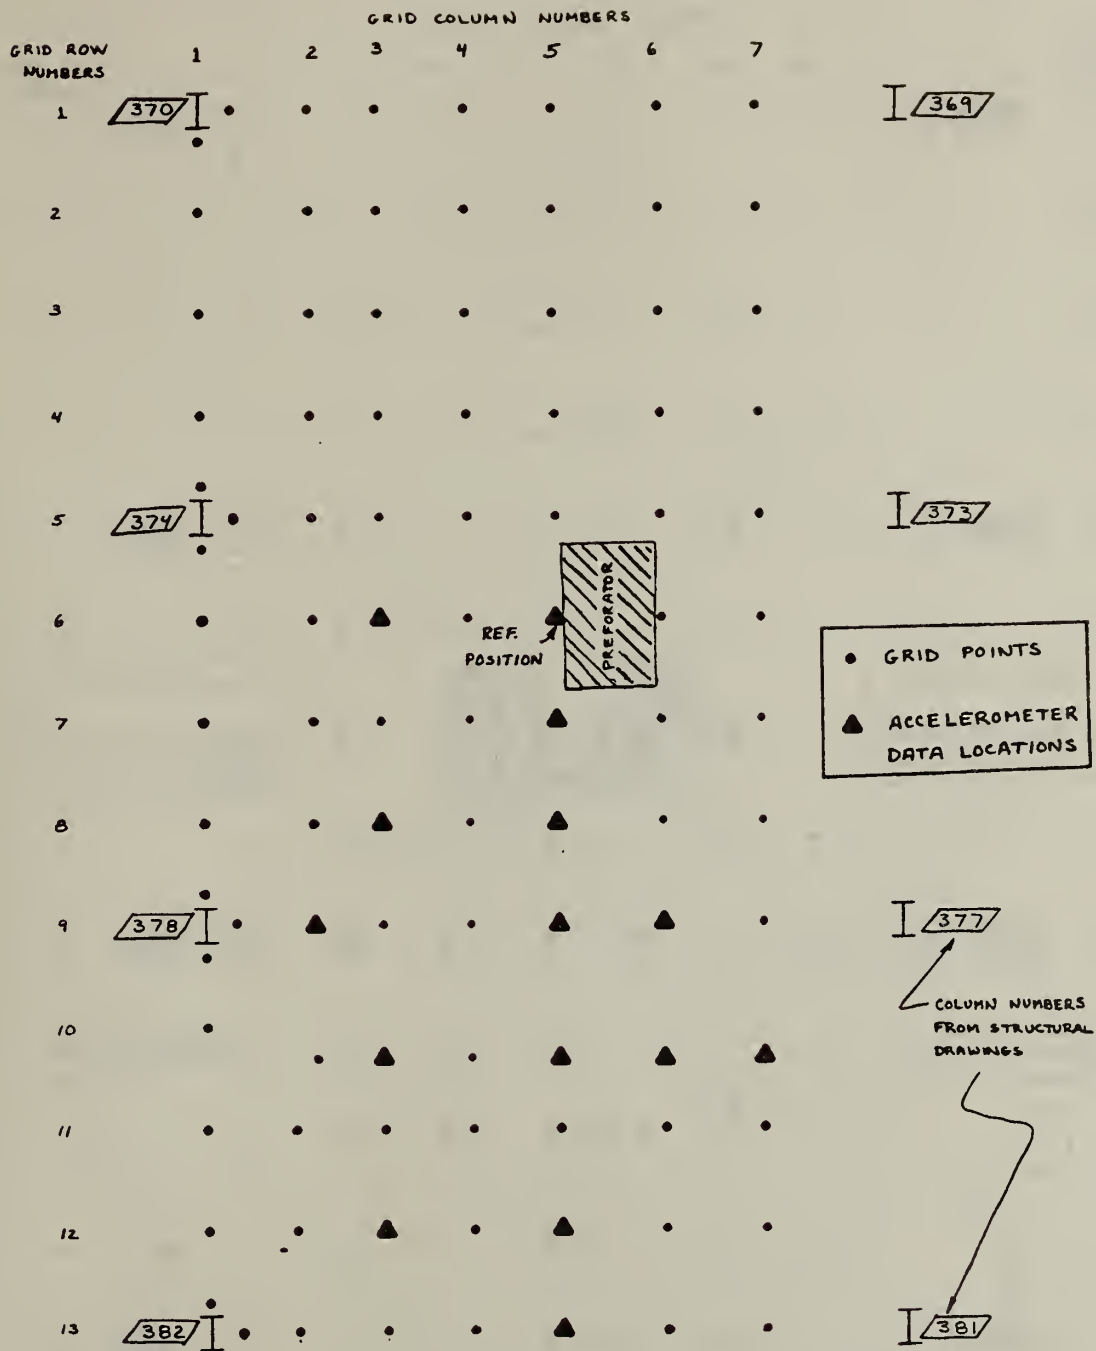
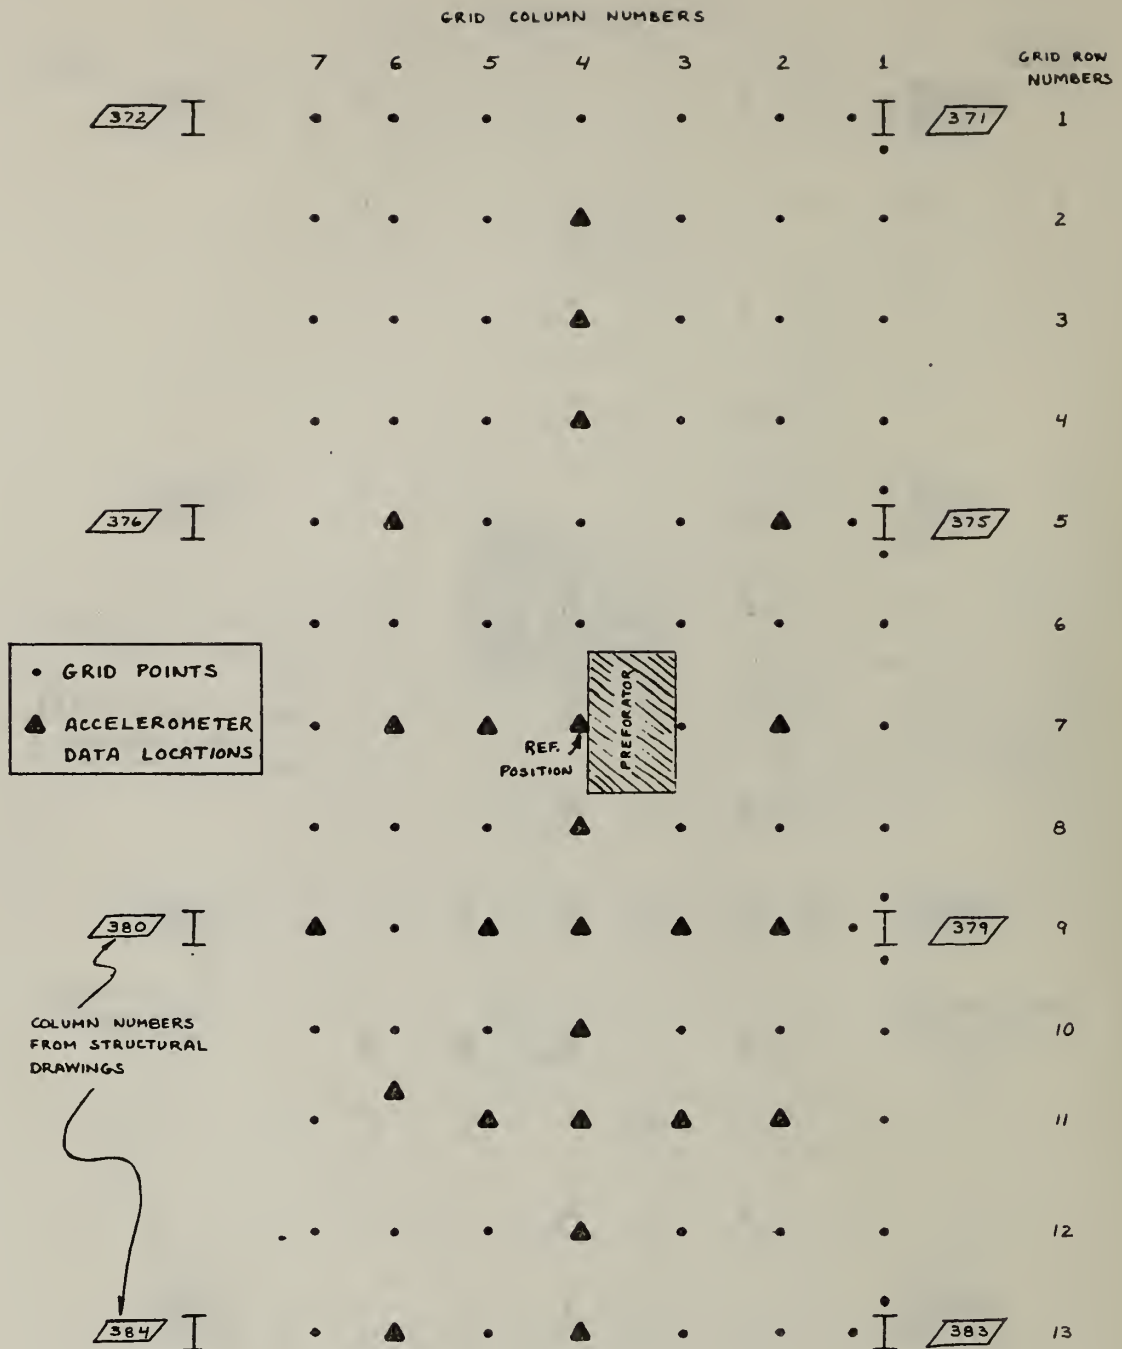
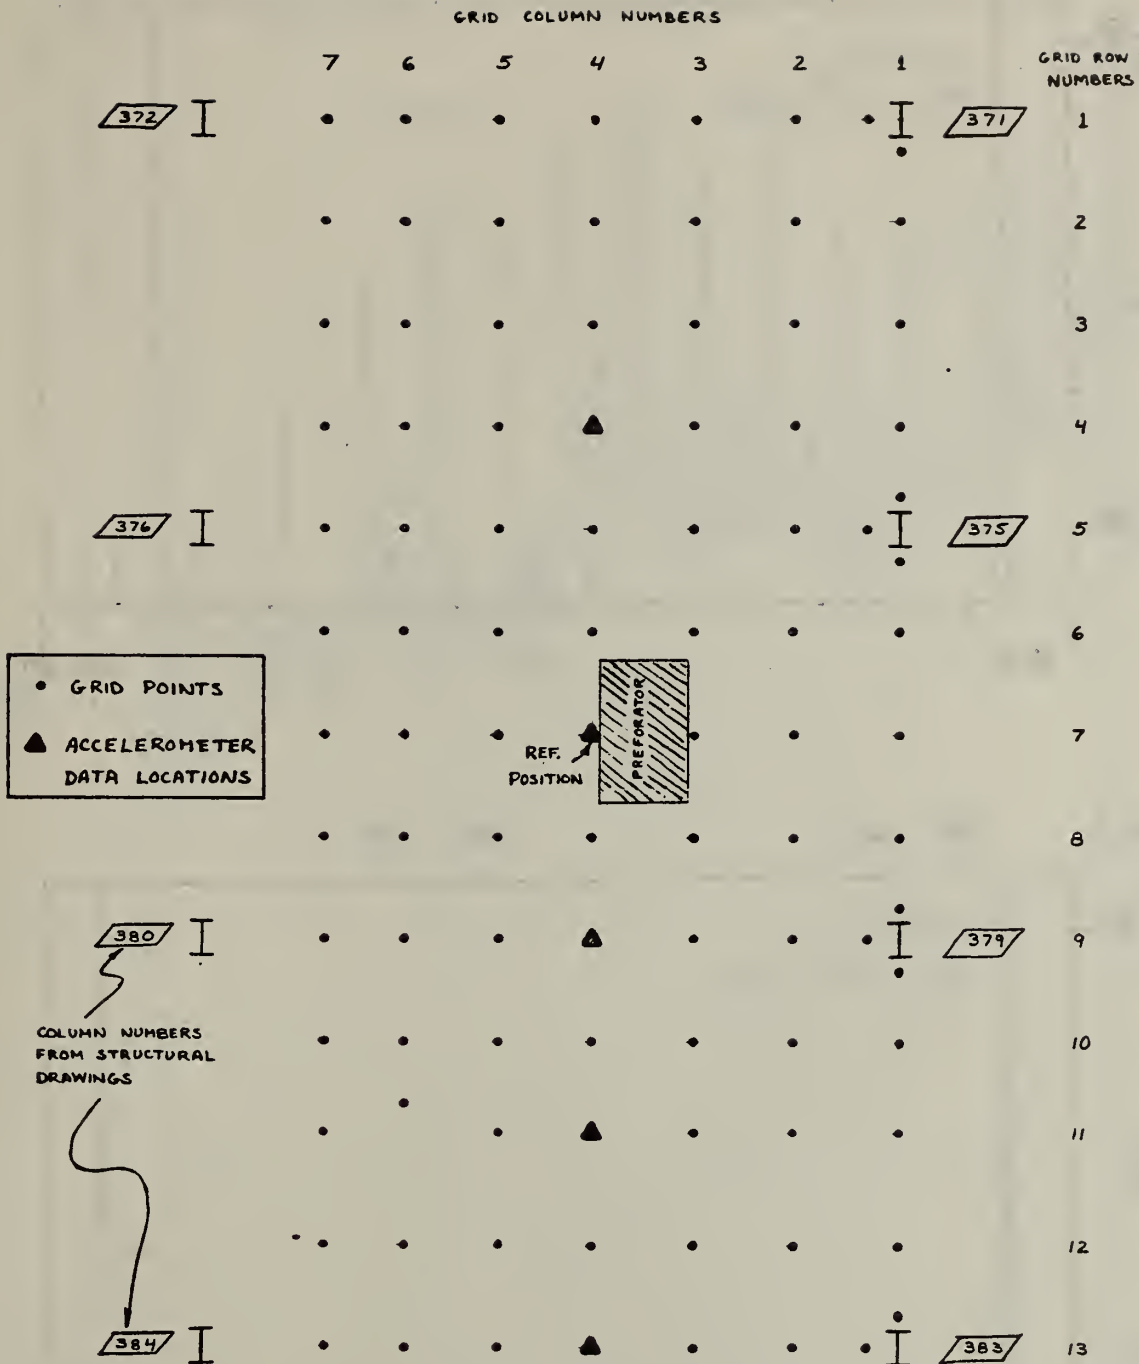
FIG. 4: Locations at which Vibration Data were Taken on North Floor with Machine Web Speed of 125 Feet/Minute.

FIG. 5: Locations at which Vibration Data were Taken on North Floor with Machine Web Speed of 155 Feet/Minute.

FIG. 6: Locations at which Vibration Data were Taken on South Floor with Machine Web Speed of 117 Feet/Minute.

FIG. 7: Locations at which Vibration Data were Taken on South Floor with Machine Web Speed of 160 Feet/Minute.

points. These data could then be used to estimate mode shapes. Locations at which acceleration measurements were obtained are shown in Figs. 4, 5, 6 and 7.

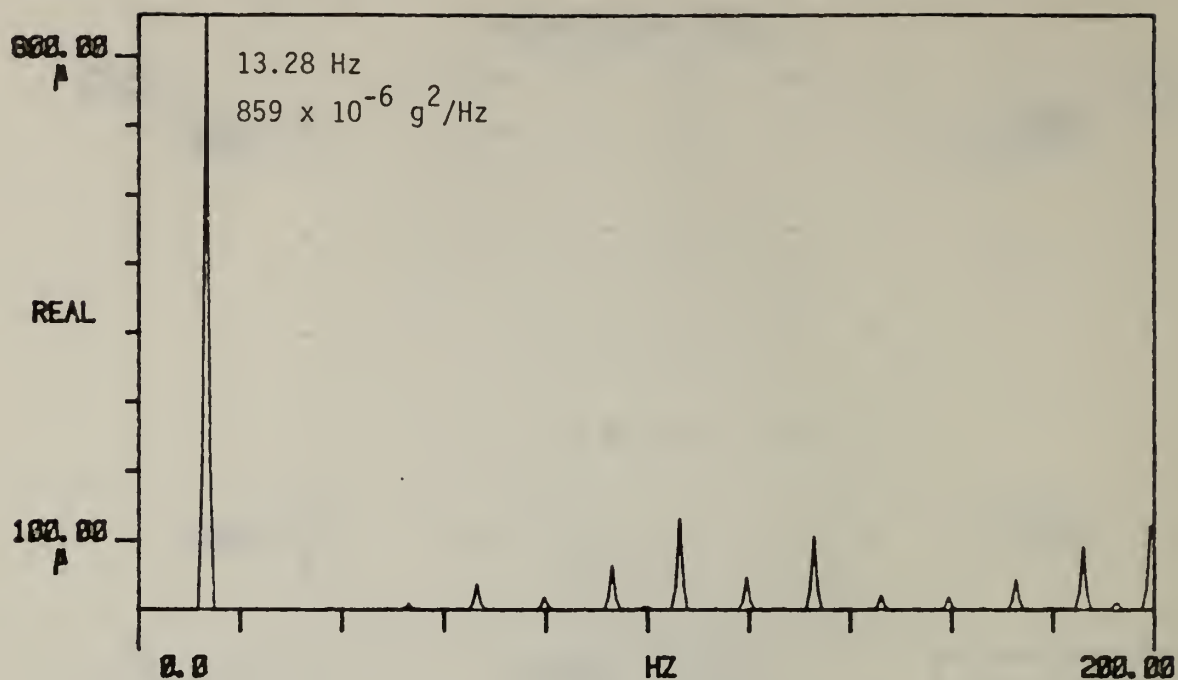
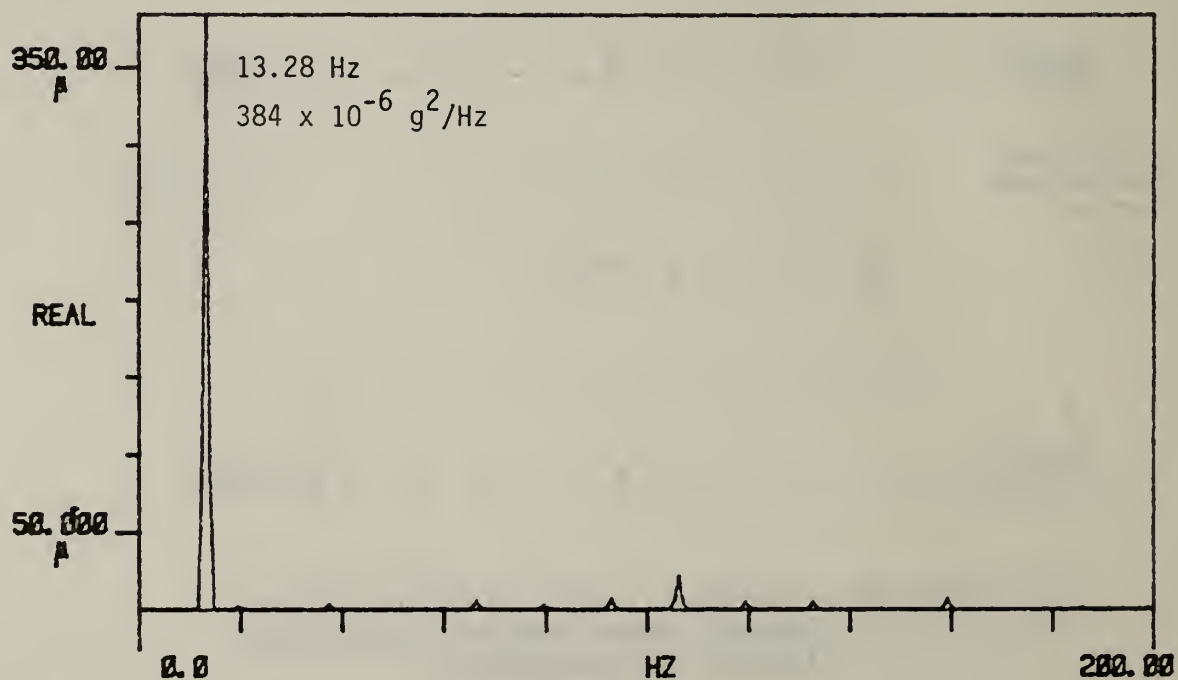
FIG. 8: Typical Power Spectra at Two Points Indicating Relative Magnitudes of Accelerations.

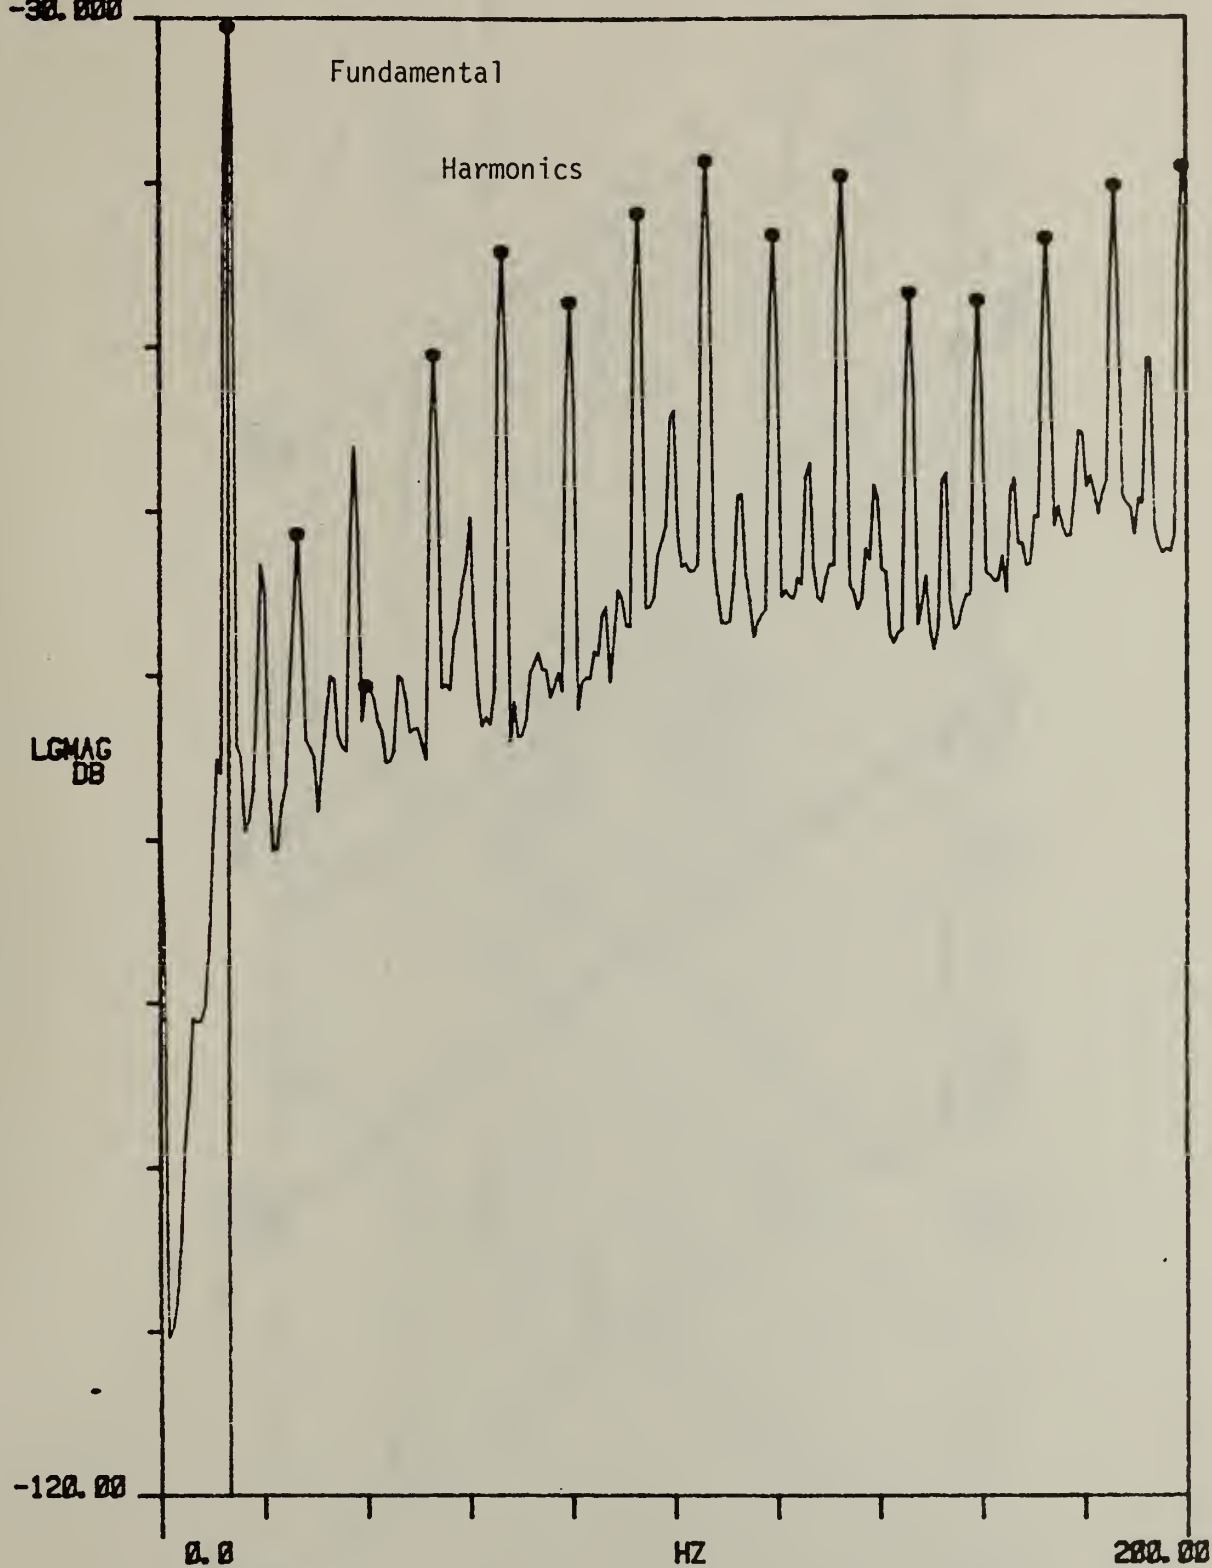
FIG. 9: Log-Plot of Typical Auto Spectrum with Resonant Frequency and Harmonics Identified.

The factor, 1.1719, in the equation for A_r is related to the window function used in the spectral analysis and was supplied by the manufacturer of the spectral analyzer. The other equations result from assuming simple, harmonic motion and knowing the acceleration. Typical plots of the auto-spectra at two locations are shown in Fig. 8. Fig. 9 shows a log plot of one of the spectra with the harmonics of the resonant frequency identified.

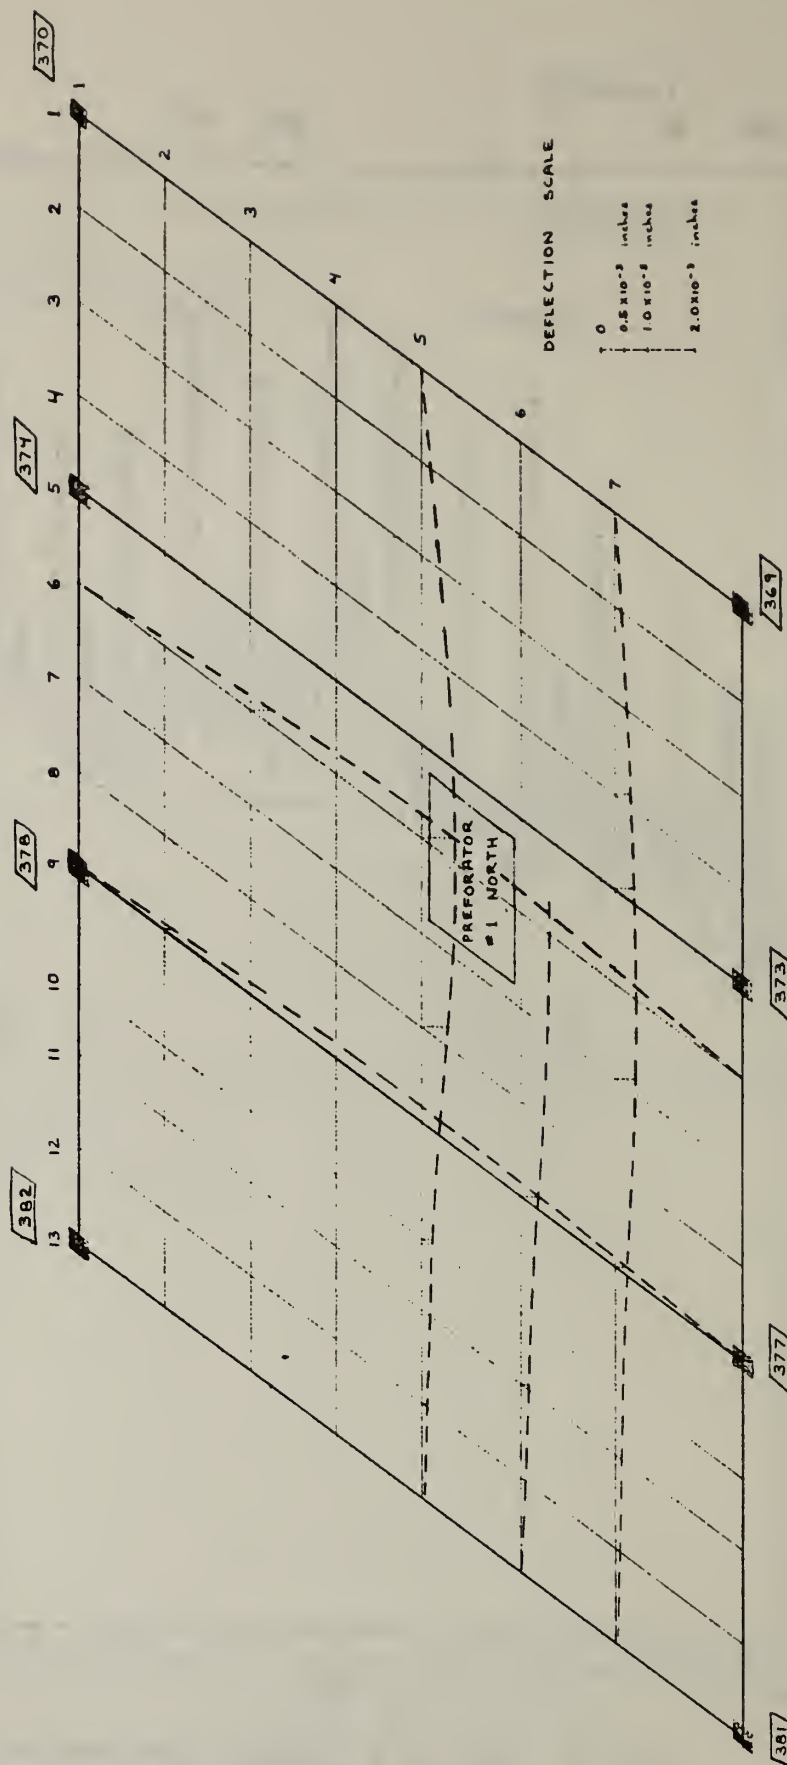
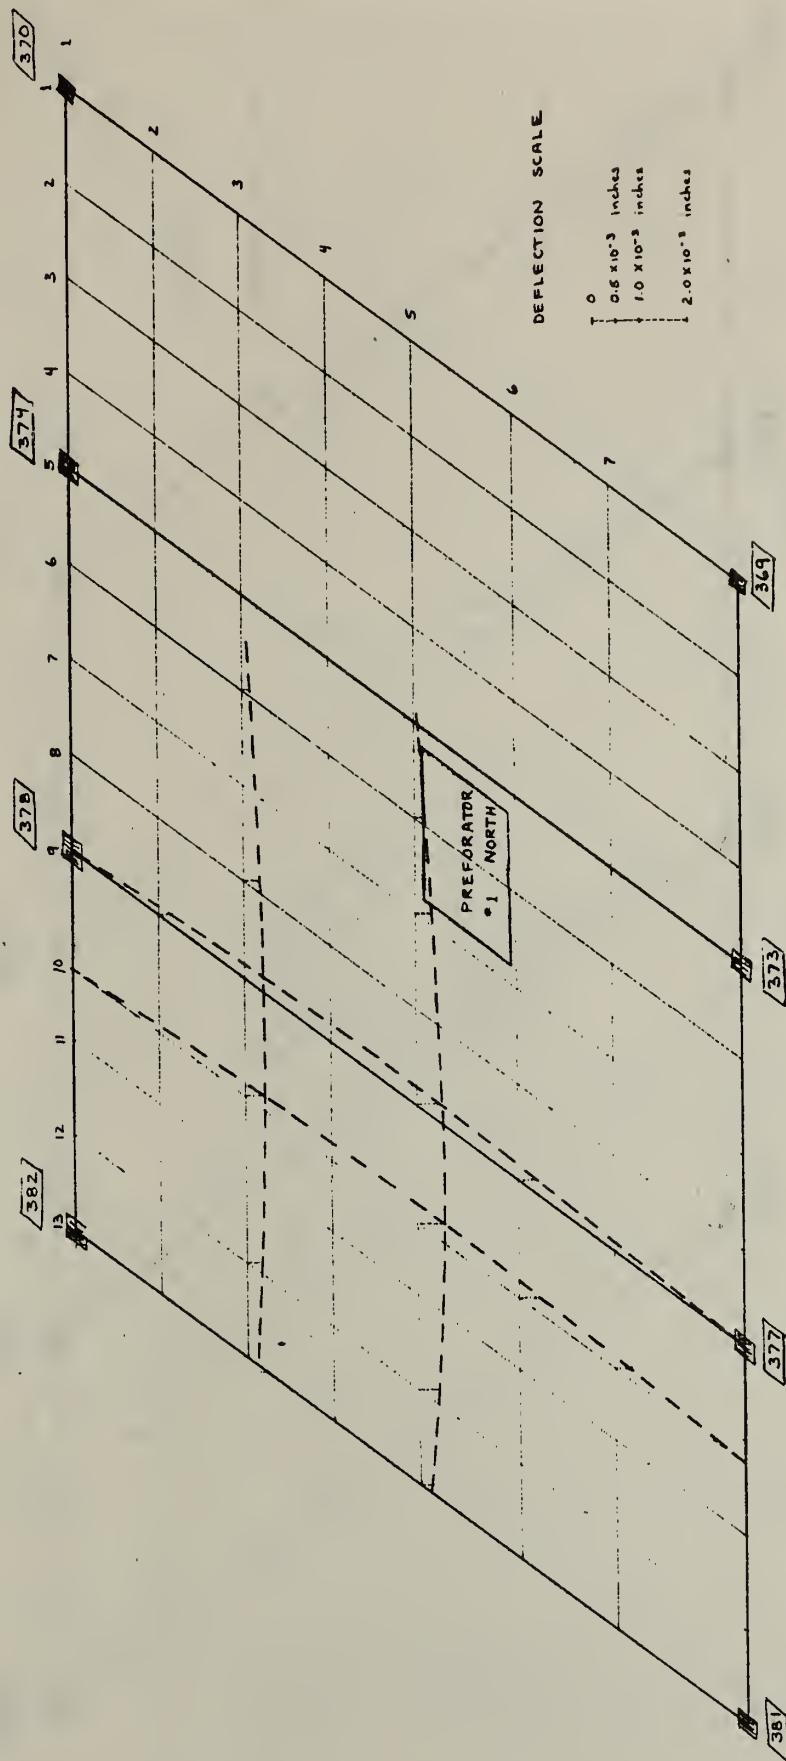
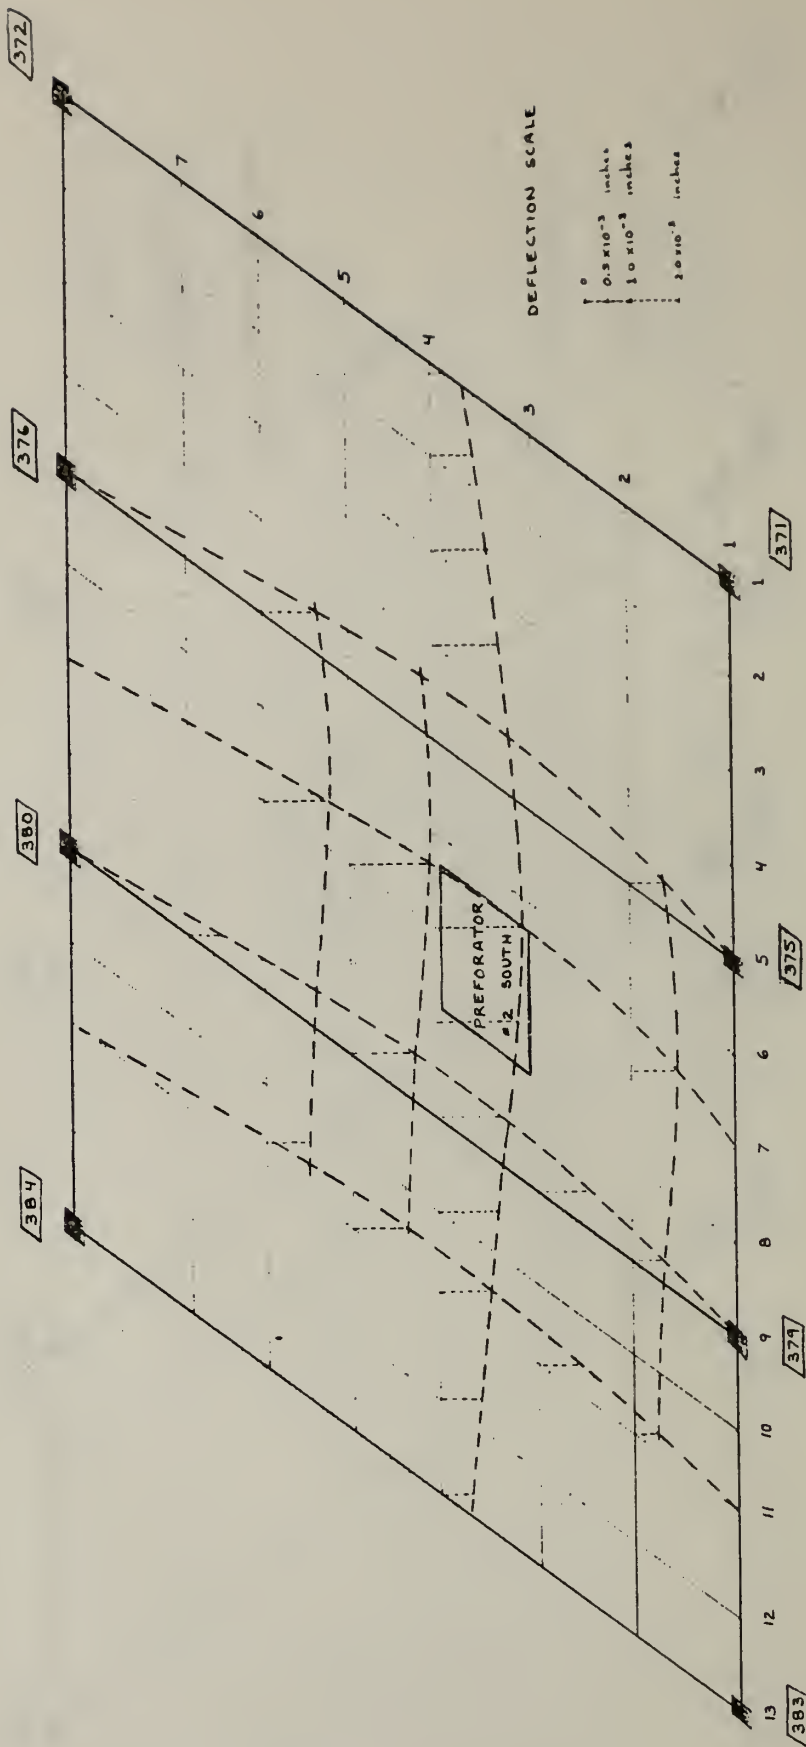
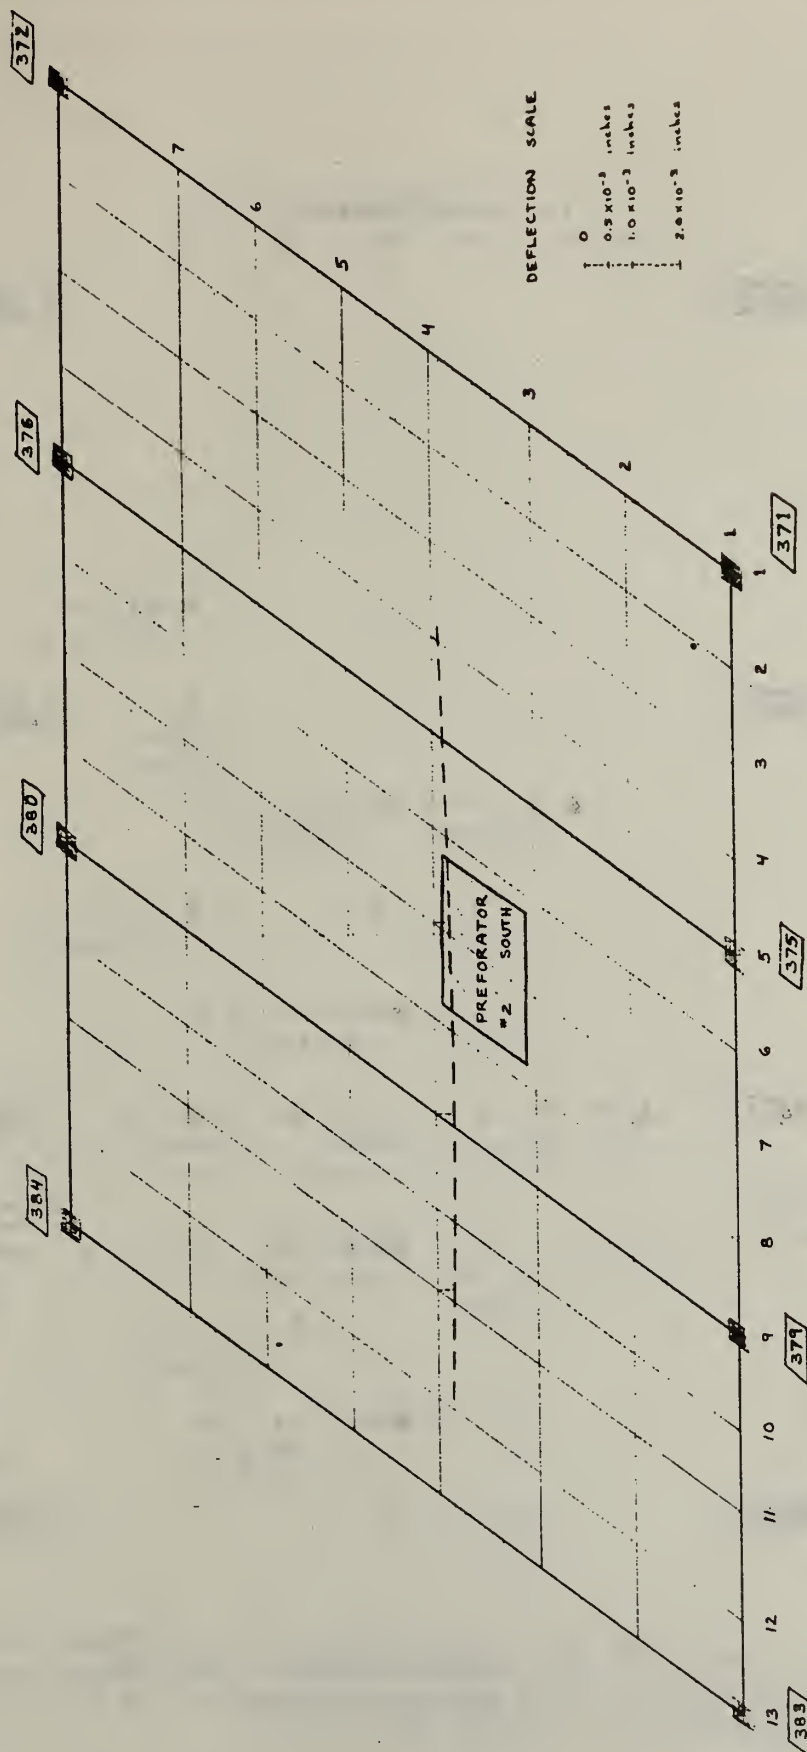
FIG.10: Mode Shape of North Floor Vibration
 at 14.07 Hertz with Machine Web
 Speed of 125 Feet/Minute.

FIG. 11: Mode Shape of North Floor Vibration at 17.97 Hertz with Machine Web Speed of 155 Feet/Minute.

FIG. 12: Mode Shape of South Floor Vibration at 13.28 Hertz with Machine Web Speed of 117 Feet/Minute.

FIG. 13: Mode Shape of South Floor Vibration at 18.75 Hertz with Machine Web Speed of 160 Feet/Minute.

Mode shapes were estimated from relative vibration amplitudes and phase angles. The phase angles, in turn, were obtained from the cross-spectra. The mode shapes associated with the forced vibration at the two operating speeds for each of the two floor systems are shown in Figs. 10, 11, 12 and 13. Note that the mode shapes indicate that the floor systems acted like large plates.
